Analysis on the Generation and Control of Strip Defects on the Surface of Color Coated Plates

Li Hai-ying

School of Higher Vocational Technology, University of Science and Technology Liaoning, Anshan, 114044,
China E-mail:lnaslhy@163.com

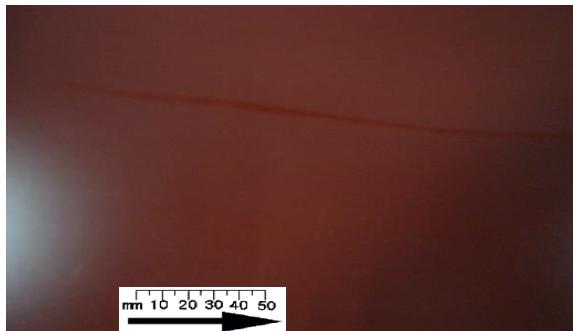
1. The dirt line for the strip coating surface showed continuous floral strip depression defects.
2. Drawing is the strip surface was wire-like, with the strip color defects. Generally non-continuous, irregular through the strip up and down the surface.
3. The stripes are regular surface of the coating surface

Figure 1 dirt line

There is a floating foreign body between the coating roller and the strip or between the roller and the roller. The surface of the coating film is missing from the surface of the coating process, and the line is easy to travel.

1.1 the conversion of raw materials need to be connected to the need for suture, suture process prone to iron, burrs, the coating will fall when caught between the roller and the extraction roller, and then produce dirty line defects.

1.2 for a long time production, for the pump before the export pipe filter filter impurities increased, prone to clogging leakage, a filter into the paint, so that the slag material into the strip surface, resulting in dirt line.

1.3 painting roller, paint plate, scraper, foam device, the circulatory system and other equipment, pieces of cleaning is not complete, easy to cause dirt line.

1.4 paint in the mixing, transportation, construction and use of the process, by dust, mosquitoes and other debris pollution, prone to dirty lines.

1. dirt line prevention and control measures

1.1 strip suture, the need for strip suture joints to purge, in order to avoid suture iron clip caught in the suture into the coater caught in the roll gap between the defects.

1.2 for the paint pump need to install the filter, and regularly remove the pump filter cleaning, timely inspection, replace the filter to ensure the quality of filtration.

1.3 the need to strictly ensure that the coating environment and painting tools clean, clean and no foreign body, no variegated.

1.4 the need to strictly control the external environment of the coating area for anti-mosquito, such as operating room door status, lighting opening and closing, personnel access and other aspects of control.

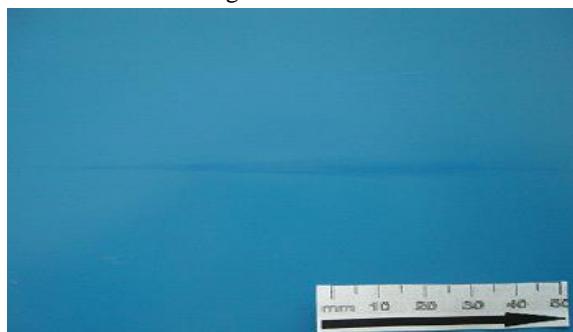
Figure 2 drawing

2.1 paint plate paint bubble too much, the coating process with the transfer roller to the strip, resulting in drawing.

2.2 the surface of the paint floating color, coating process with the transfer of roller to the strip, resulting in drawing.

2.3 roller with no material, easy to produce during the drawing process.

2. Drawing the prevention and control measures

2.1 need to make suitable for two or three roller coating with a special baffle, and adjust to the correct position, the bubble on the outside, to prevent the foam onto the roller and then brought to the surface of the steel plate to produce drawing.

2.2 the paint should be fully uniform mixing, moderate increase in the rate of paint recycling, to a certain extent, reduce the foam and the foam can effectively return to keep the foam and roller with the material zone isolation, thus eliminating the bubble.

2.3 according to the production line speed, need to adjust the extraction roller, coating roller speed, roll ratio, to ensure that the quality of roller with material.

2.4 by increasing the amount of lacquer for the paint, to increase the depth of paint inside the paint, the quality of materials with a good effect.

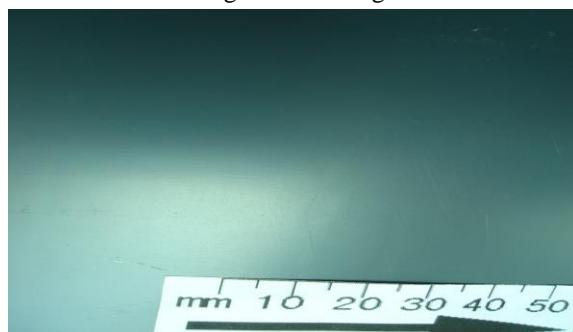
transverse or longitudinal stripes marks.

Figure 3 stripes

3.1 the surface of the substrate lattice, coated by the coating surface will still show the basic pattern marks.

3.2 roller surface is not smooth, there is into the knife pattern, resulting in here with the material and other parts of the difference, the product surface showing a continuous stripe-like defects.

3.3 paint viscosity is too large, the poor leveling of the paint, in the process of material with the strip prone to defects.

3.4 the coating roller ratio does not match, making the extraction roller with material is bad, easier to lead to stripe defects.

3. Stripes prevention and control measures

3.1 the need to check the quality of raw materials on the surface, such as the existence of a touch on the surface drawing, can not be used as raw material feed production.

3.2 for the quality of the roll, you need to use the diluent before wiping and observe the surface and the use of coating before the immersion in the slow reverse rotation of the coating to observe, visual no pattern can effectively control the stripe defects.

3.3 by adding thinner appropriate to reduce the viscosity of paint, can effectively improve the control of the stripes.

3.4 according to the production line speed, reasonable adjustment of the roller speed, coating roller speed and the ratio of the two ratio, can improve the paint with a good material.
